A HISTORY OF FULL-SCALE TESTING OF AIRCRAFT STRUCTURES AT THE NATIONAL AERONAUTICAL ESTABLISHMENT

R.L. Hewitt

National Aeronautical Establishment

AERONAUTICAL NOTE
NAE-AN-24
NRC NO. 24089

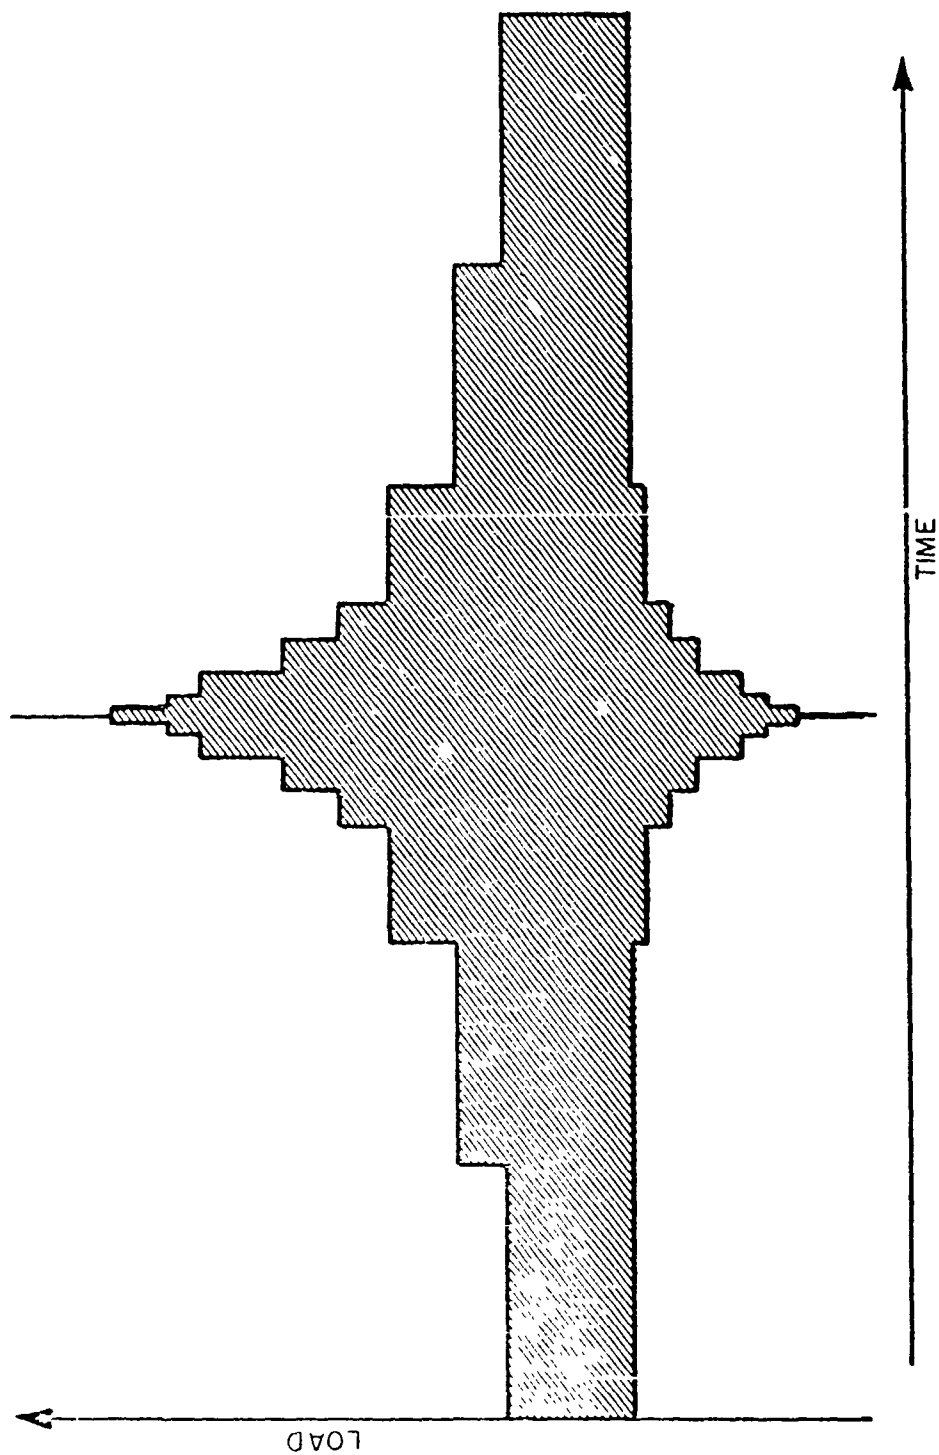
FIG. 41: NINE LEVEL LOW-HIGH-LOW LOADING SEQUENCE USED IN TUTOR
FATIGUE TEST (TRAINER ROLE)

The derived spectrum for the test⁽⁴⁴⁾ was based on counting accelerometer data from the more severe of two training bases. The loads were applied in a programmed sequence of progressively increasing and then decreasing loads of the same general form as for the CF-100 test, with each positive load cycle being followed by the negative equivalent that had the same frequency of occurrence. Since it was considered that a minimum of 30 load blocks should be applied before failure to avoid block sizing effects, and cracks had been observed as low as at 800 hours, a block size of 10 hours was chosen. Since during a typical 10 hour block only peak loads corresponding to 5.4 and -0.55g were encountered, the missing more severe loads were applied manually at the end of a group of five 10 hour blocks, so that all loads that were present in the load spectrum were applied during the course of 1000 equivalent test hours. The truncation level was set at a level that was exceeded 100 times per flight hour, which resulted in 1000 cycles per 10 equivalent flight hours compared with the 145 applied by the manufacturer.

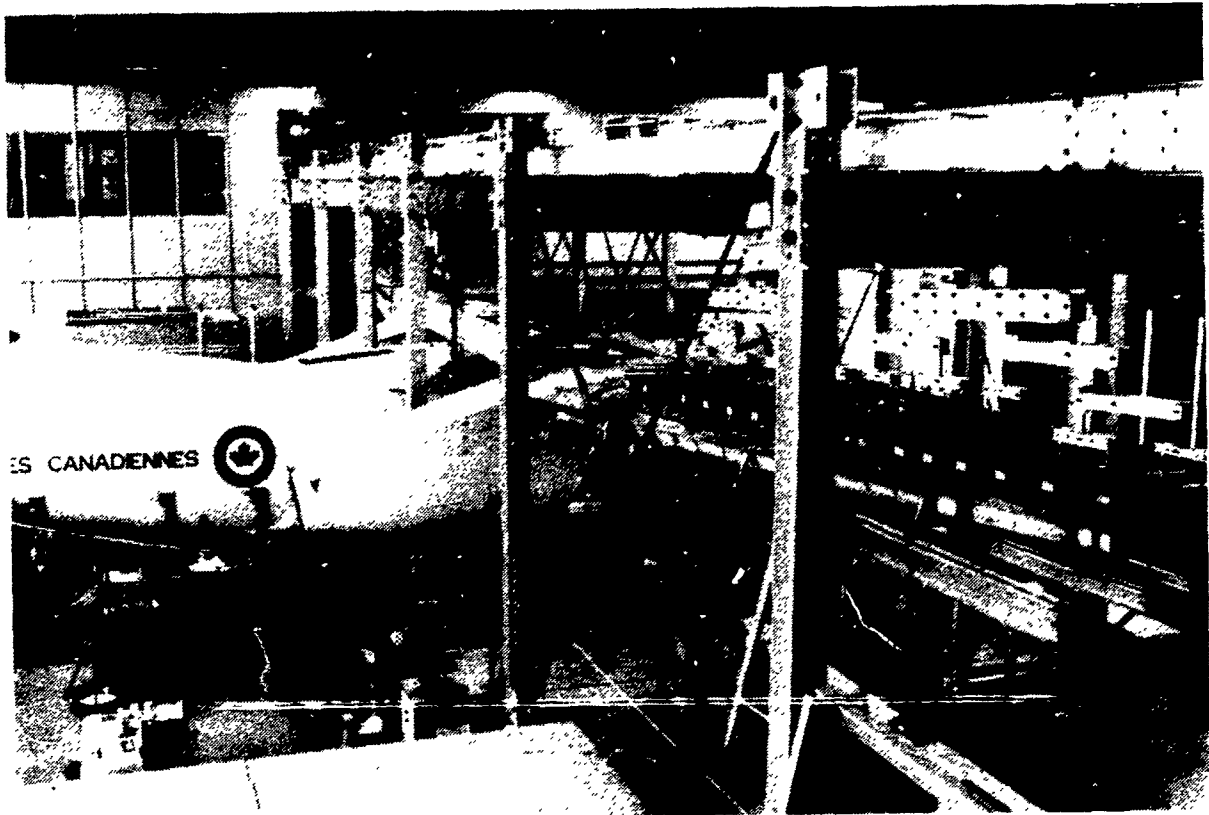
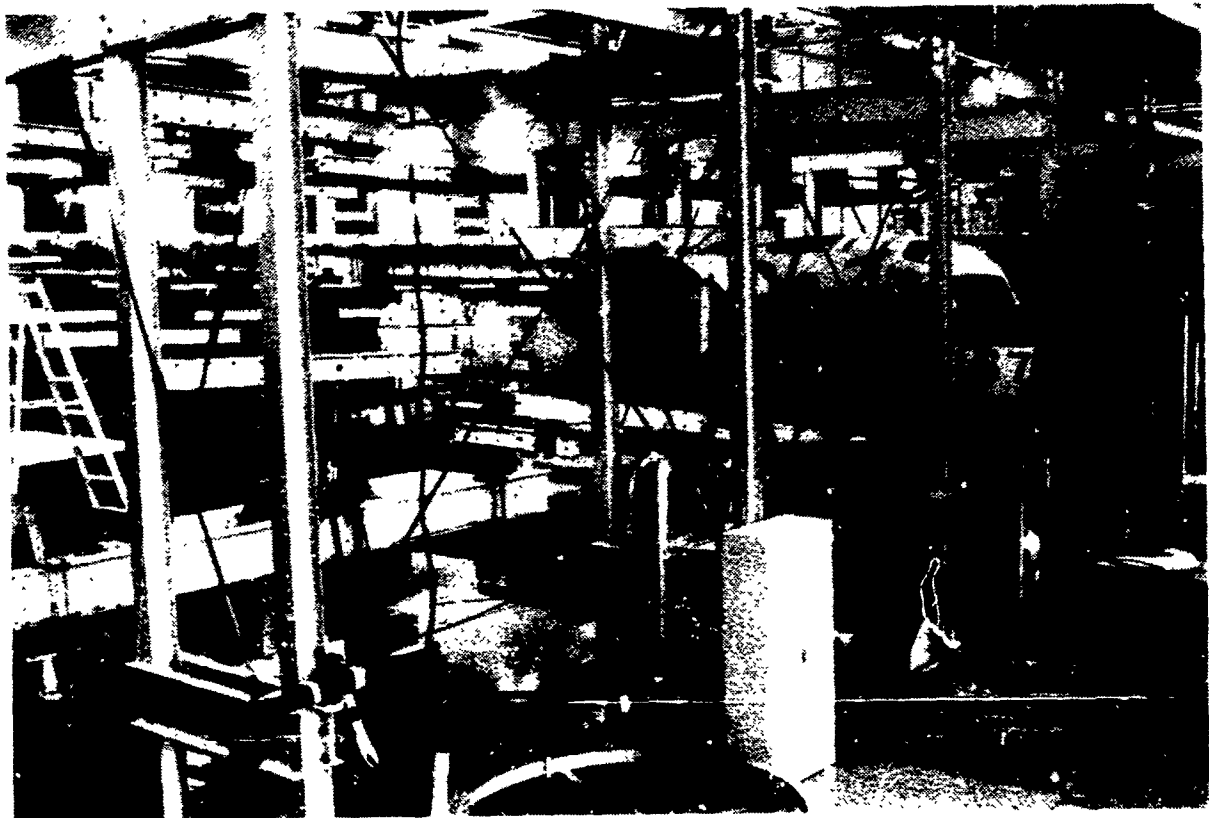
FIG. 42: TRACKER WING FATIGUE TEST SET-UP

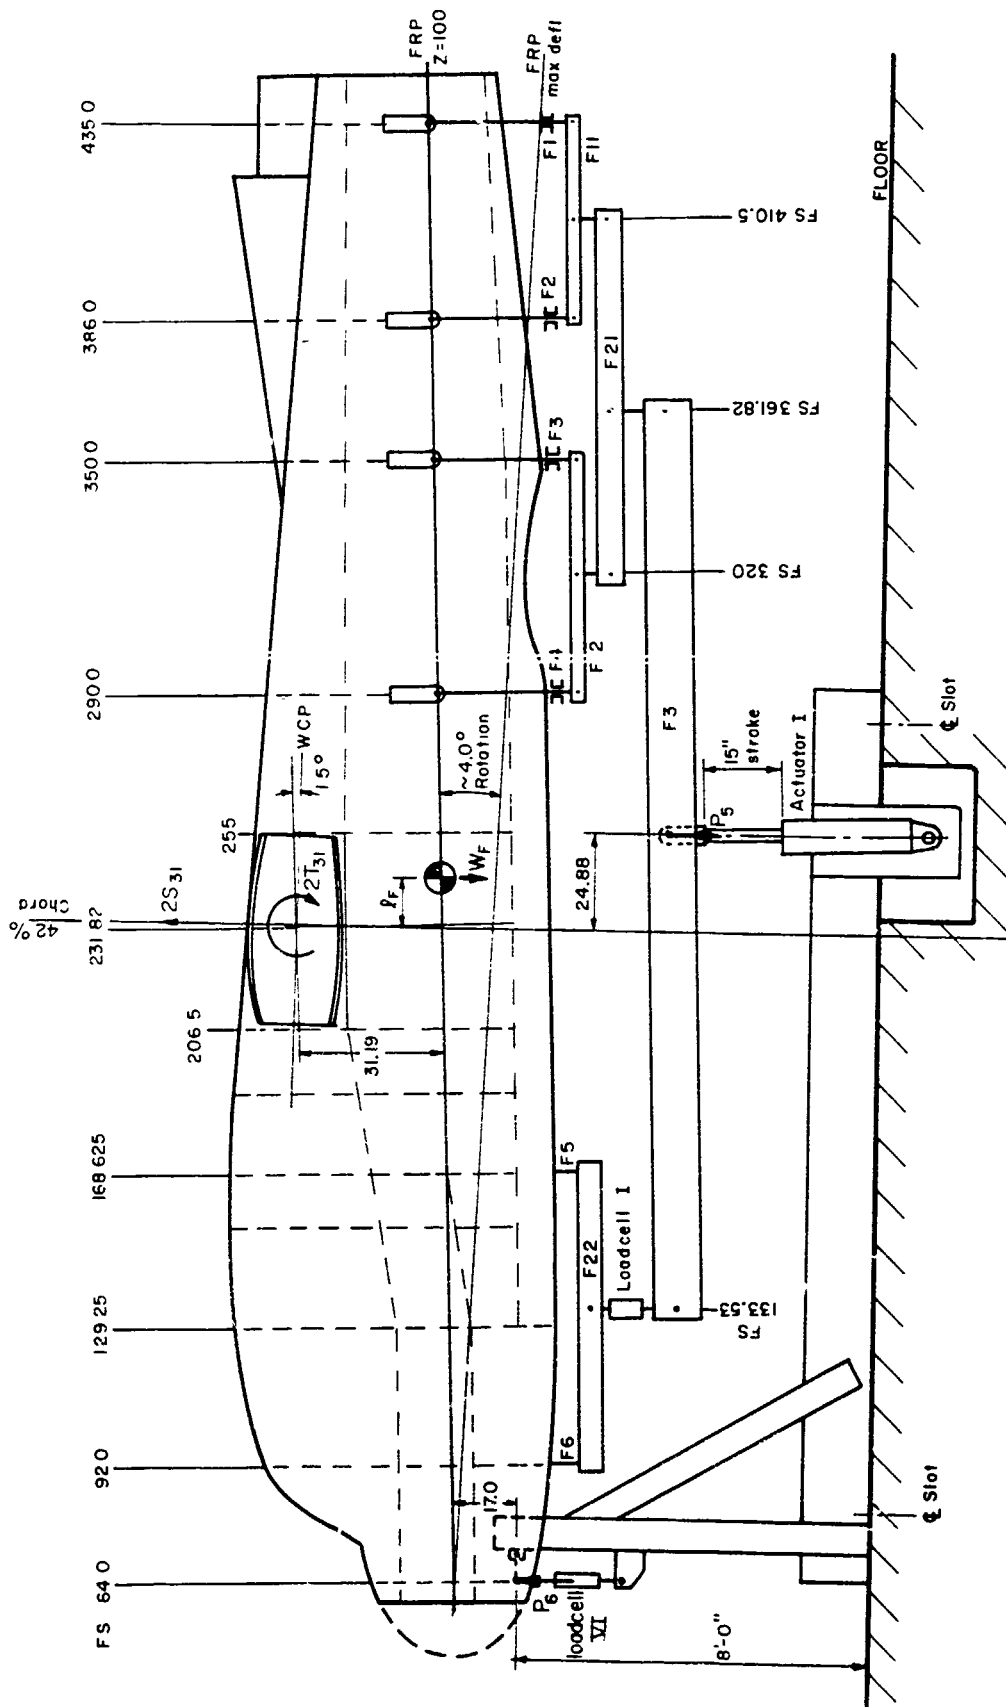
FIG. 43: UNDER FUSELAGE WHIFFLETREE SYSTEM

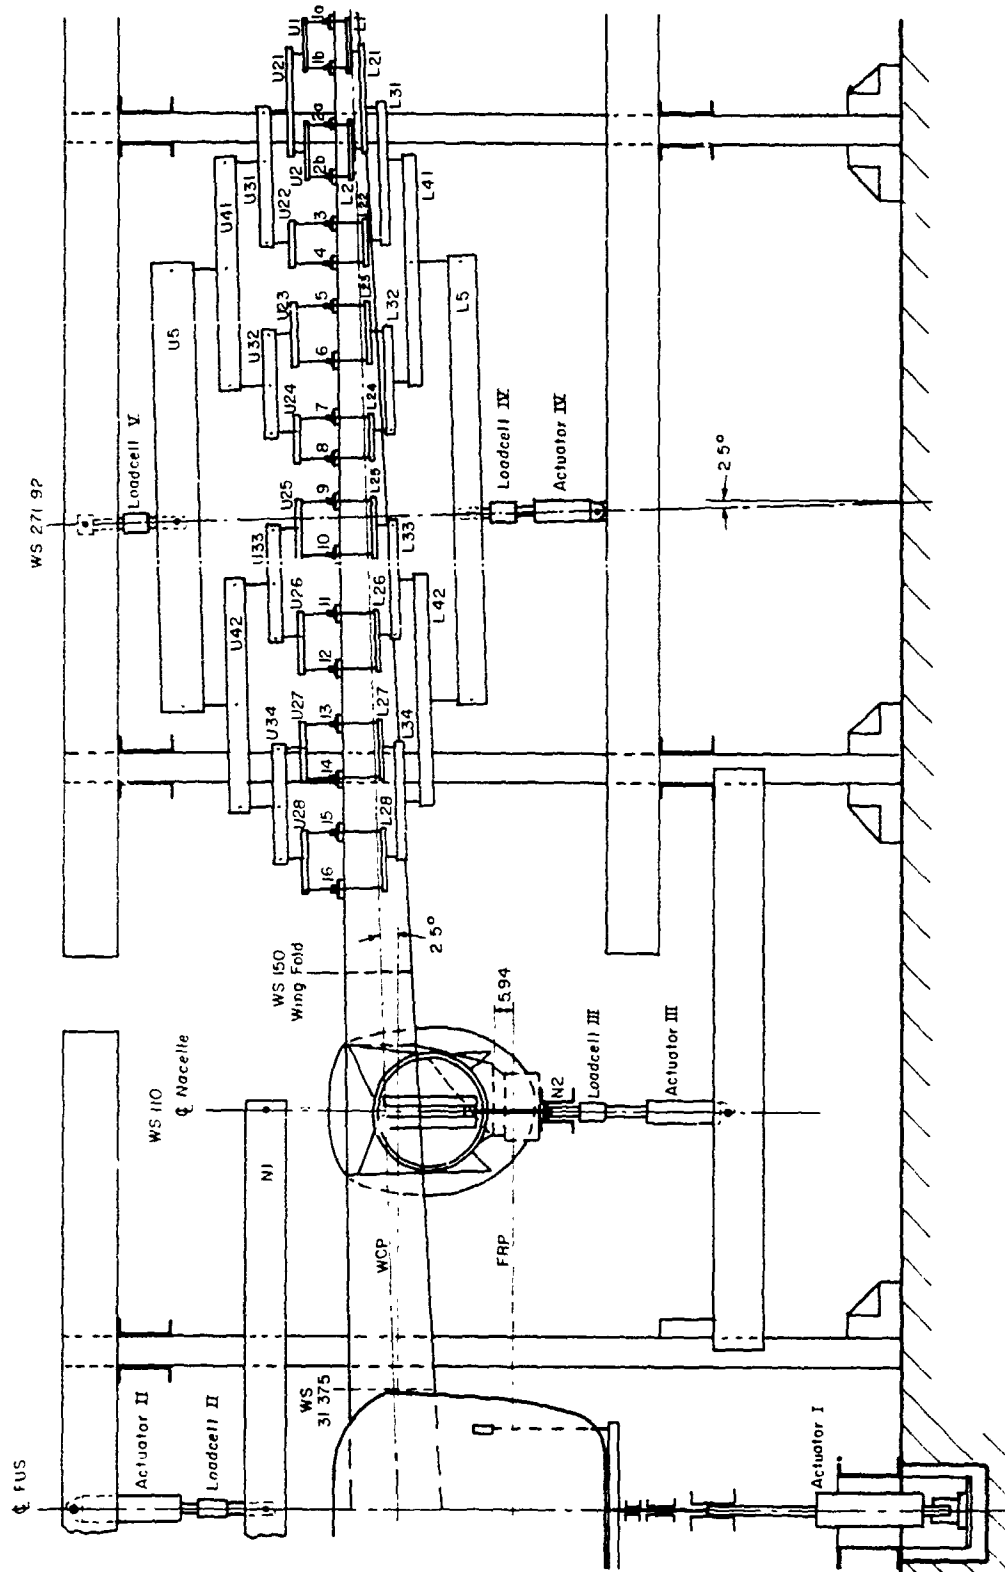
FIG. 44: TRACKER WING LOADING SYSTEM

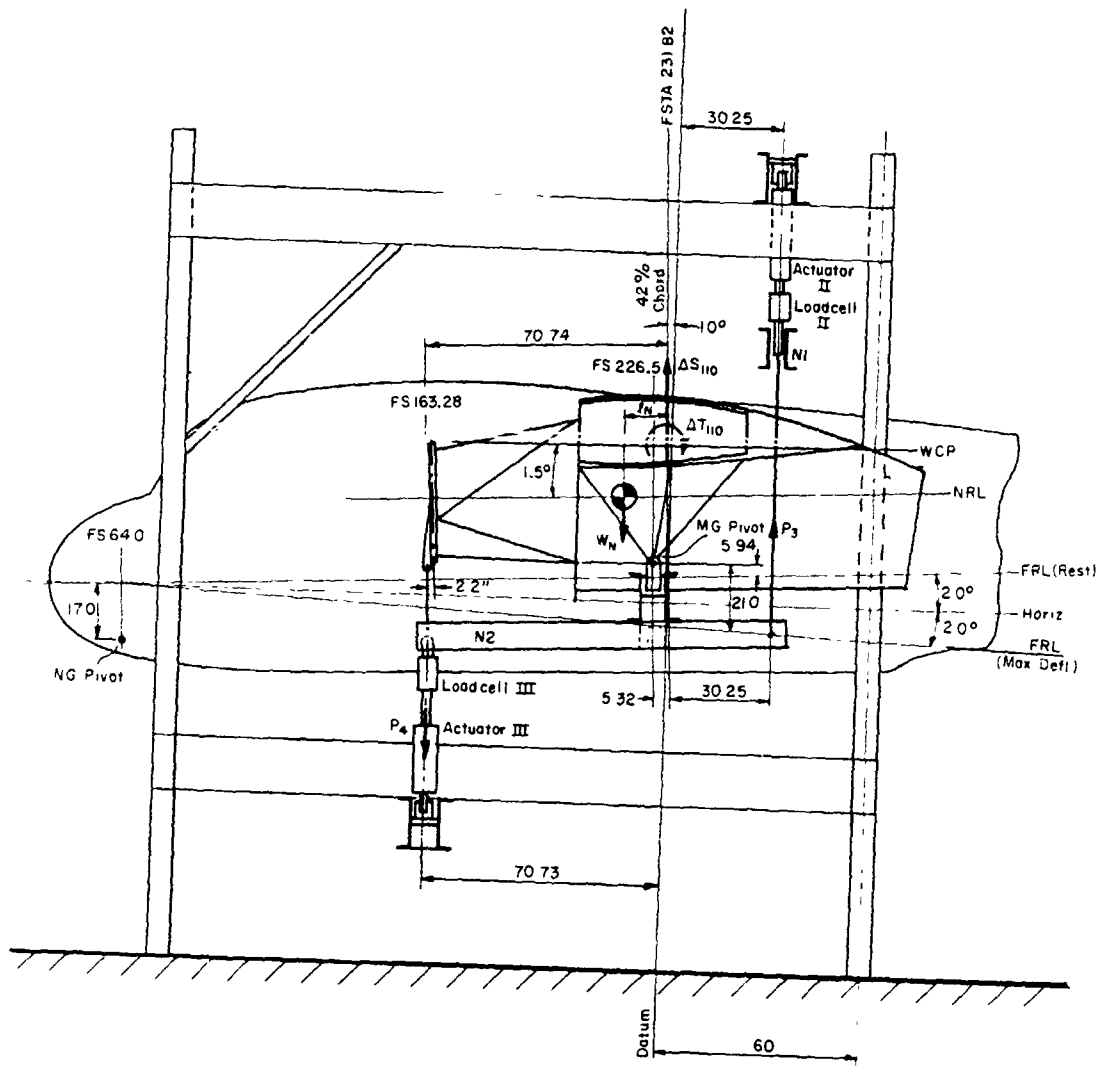
FIG. 45: NACELLE LOADING SYSTEM

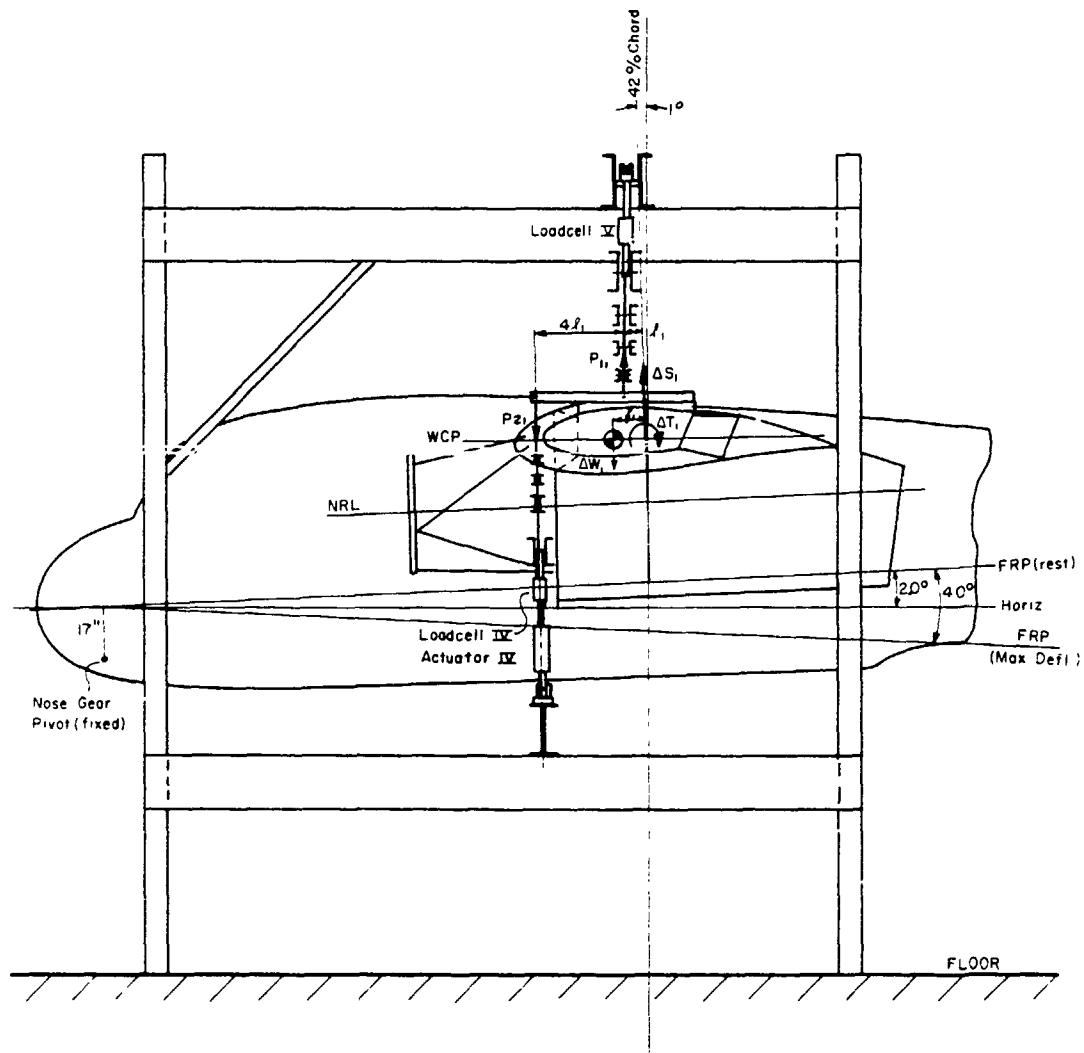
FIG. 46: OUTER WING LOADING SYSTEM
